Task Force to Investigate the Interaction between Substation Transients and Transformers in HV and EHV Applications for the IEEE Power & Energy Society - Transformers Committee Performance Characteristics Subcommittee

Task Force Work Summary

Abstract – This paper summarizes the work performed by the task force to investigate potential revisions to C57.142-2010 IEEE Guide to Describe the Occurrence and Mitigation of Switching Transients Induced by Transformers, Switching Devices, and System Interaction. Although the scope of this document does not exclude HV and EHV systems, the existing document primarily includes examples and information on distribution voltage systems. A task force was formed to investigate the need to include more information in this existing document on higher voltage systems. The task force was charged with the following tasks:

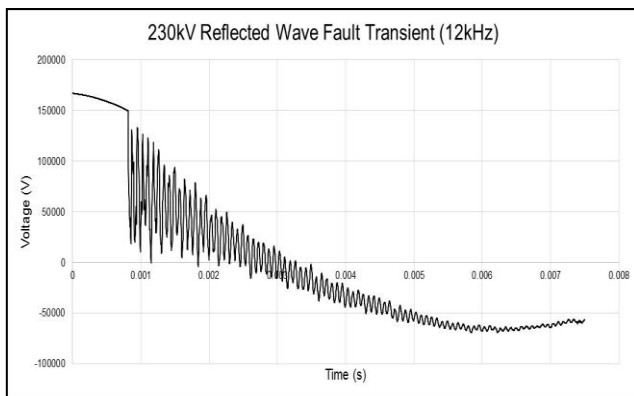
A recording of a fault transient caused by a 230kV system fault at a distance of 3.1 miles from the measurement point is given in Figure 1.

Figure 1
230 kV System Fault Transient
(Distance to Fault = 3.1 miles
Reflected Wave Frequency = 12 kHz)

Third, there is the possibility of setting up a traveling wave caused by the rapid collapse of the bus voltage when the uncharged capacitor bank is connected to the bus. This could produce an oscillating waveform because of conditions similar to those in Figure 1. Just as in the back to back capacitor switching, this type of interaction can cause higher frequencies. However, again, the lack of significant numbers of transformer failures indicates that this type of interaction is not typically a problem.

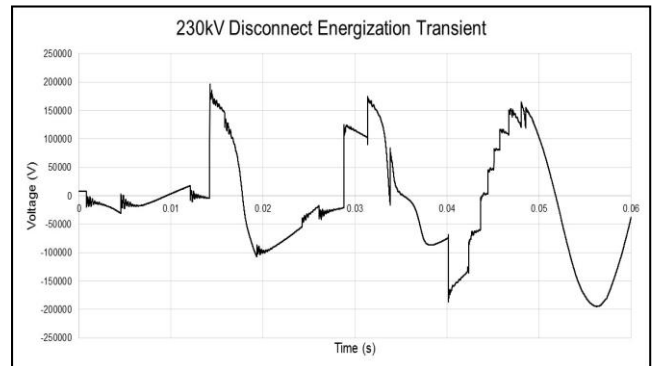
Figure 5
Disconnect Switch Energization Transient

A sample energization voltage event recording caused by energization of a 60MVA transformer using a 230kV circuit switcher closure is shown in Figure 5. The operation is the closing of an air insulated disconnect switch. In this case, several restrikes and reignitions can be seen on the voltage waveform before the switch blades engage and complete the energization of the transformer.
